WakeMed North Hospital

Challenge: Raising the Bar - Hospital Expansion Streamlines Approach to Ensure Enclosure Continuity

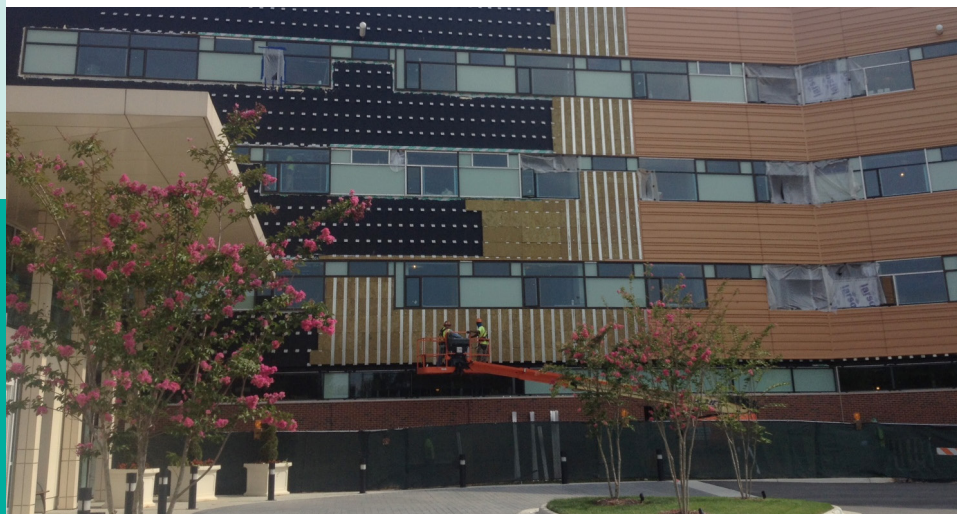
SECO Architectural Systems provided a comprehensive approach to the building enclosure including a continuous Tremco air barrier system behind the metal panels, which added moisture control and waterproofing while ensuring the integrity of the wall assembly.

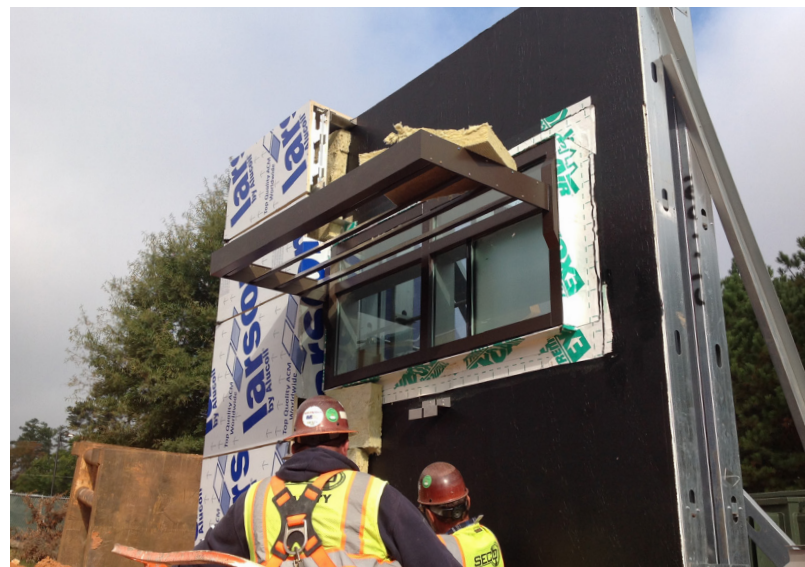
The single-source approach helped to ensure the continuous control layers mandatory for a high-performance building. The air barrier was rolled on, the rough openings were wrapped, and the fenestrations were sealed by people skilled at the use of those products and without compatibility challenges.

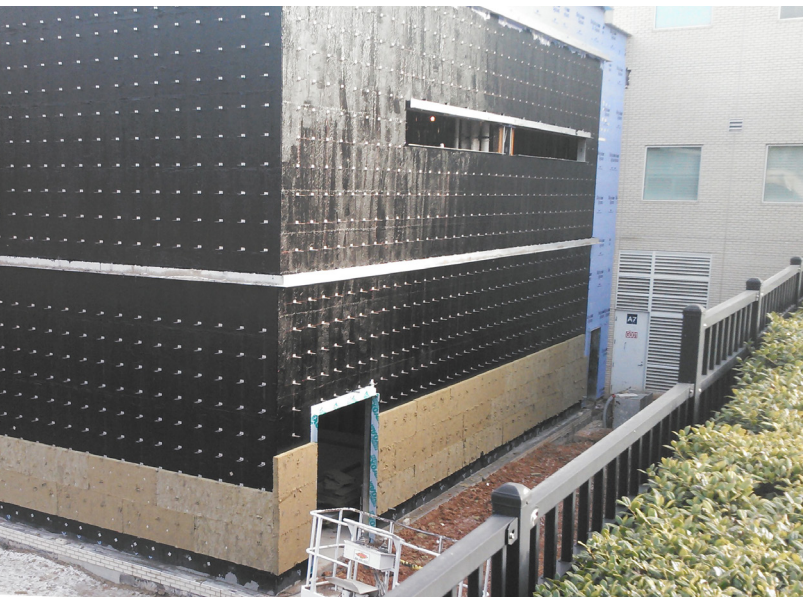
Tremco’s ExoAir® 220 Fluid-Applied Vapor-Permeable Air Barrier Membrane has been applied to the wall of the extension and ExoAir® 110 Self-Adhered Air and Vapor Membrane at the door opening. The brick tie bases have been installed, and SECO has started installing the mineral wool insulation.

On WakeMed North Hospital, Tremco's ExoAir® 220 Fluid-Applied Vapor-Permeable Air Barrier Membrane, ExoAir® 110 Self-Adhered Air and Vapor Membrane and Spectrem®1 and 2 Silicone Sealants comprised the above-grade system. ExoAir 220 is a vapor-permeable system that will seal the walls from air infiltration and exfiltration while allowing vapor molecules to pass through, so they do not get trapped within the wall. Though a vapor-permeable air barrier system may be used in many cases in the hope of ensuring success of the job, a poorly constructed system will not compensate for moisture transported through a breach. Wall components may not be able to dry out quickly enough to prevent damage from moisture accumulating within the wall.

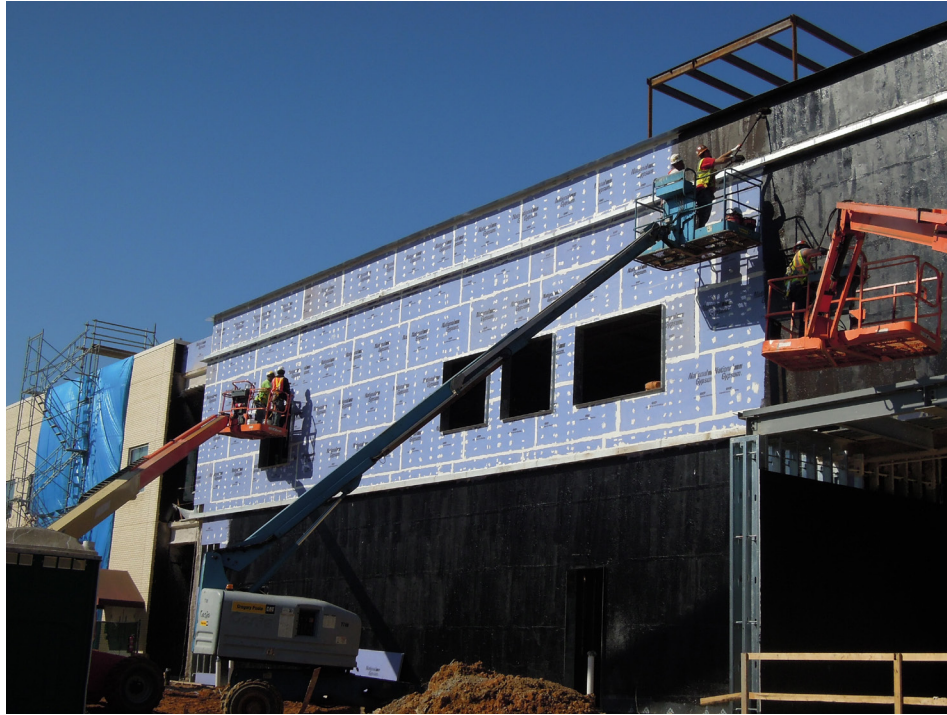
By providing the metal panels, waterproofing and air barrier, SECO Architectural Systems was able to ensure an attention to detail that would eliminate any surprises and any finger pointing in the event of a problem.

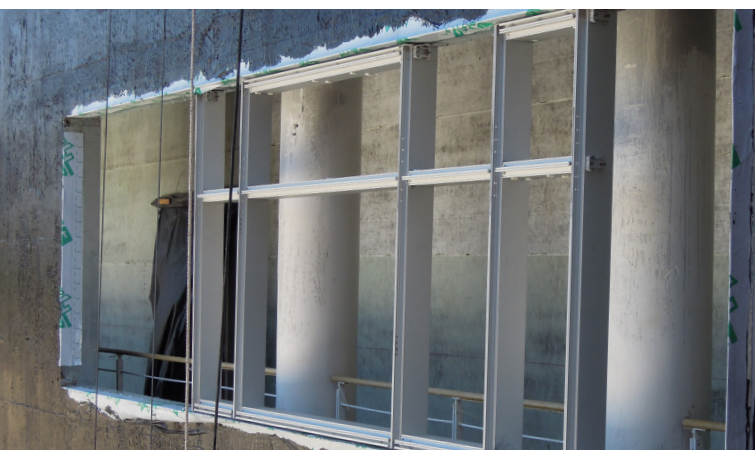
Spectrem 1 Silicone Sealant made it easy for installers to provide a secure seal for dynamically moving joints at aluminum curtain walls and window perimeters, metal panels, and the polyethylene-faced self-adhering air barrier membrane.

Spectrem 1 and Spectrem 2 Silicone Sealants were utilized at the fenestrations, louvers and metal panels. Three different colors were used, depending on the application. Spectrem 1 is ideal for sealing the most demanding dynamically moving joints including material having a high coefficient of linear expansion such as aluminum curtainwalls, precast concrete panels, metal panels and window perimeters. It also has excellent adhesion to most polyethylene-backed self-adhering air barrier membranes. The glazing contractor had "absolutely no hesitation" at using the Tremco silicone as they used it frequently and considered it "one of the best." "The curtainwall sits far out on the skin system, making the transitions really important. The Spectrem silicone sealants passed all the water tests of the mockup and made it easy for the metal panel and glass installers," remarked Crabtree.
